EARLY DETECTION OF DAMAGE IN HEAVY DUTY COMBUSTION TURBINE BLADES FOR ELECTRIC GENERATION

P. MAGNESCHI *, G. TIRONE *

PRESENTED BY: G. TIRONE PISA 27/9/2000

* ENEL PRODUZIONE S.p.A. TORINO - ITALY

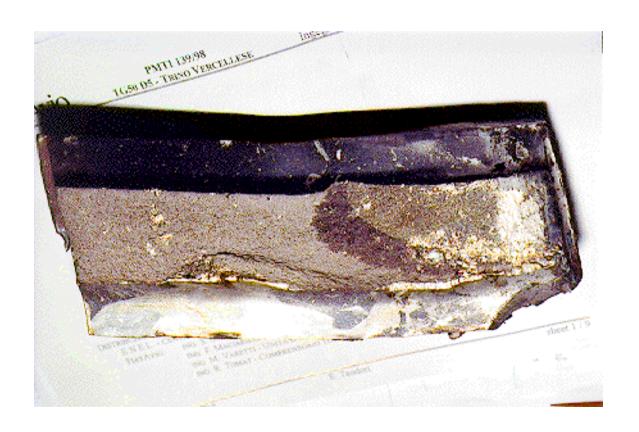
- THE FAILURE HAPPENED ON THE UNIT TRINO 12
- AFTER A LOAD REJECTION TEST THE GAS TURBINE TRIPPED DUE TO LOW SPEED/HIGH VIBRATIONS
- THE GAS TURBINE EXPERIENCED, AT THE MOMENT OF THE FAILURE, 16659 OPERATING HOURS AND 139 STARTS
- DURING THE FOLLOWING INSPECTION THROUGH THE MANHOLE ON THE TURBINE DISCHARGE DUCT THE LOSS OF 1-4TH STAGE BLADE WAS FOUND
- DAMAGES ON OTHER 4TH STAGE BLADES, 4TH STAGE VANES
 AND DISCHARGE DIFFUSER WERE FOUND TOO

BLOCK OF 4TH STAGE FAILED BLADE

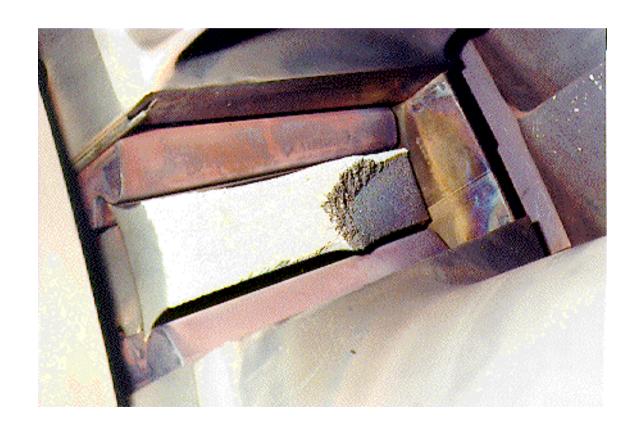
RESIDUAL BLOCK OF FAILED BLADE

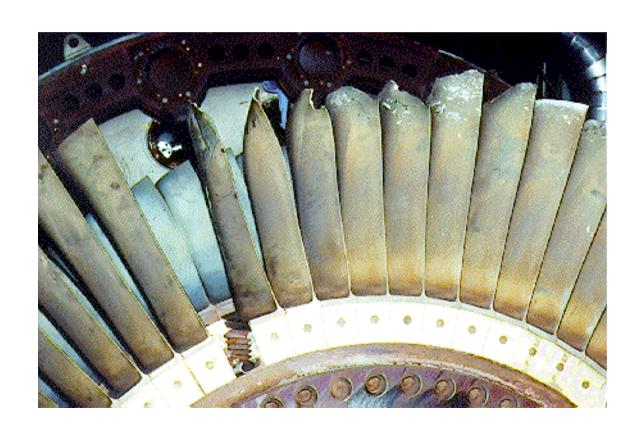
4TH STAGE BLADES AFTER THE FAILURE

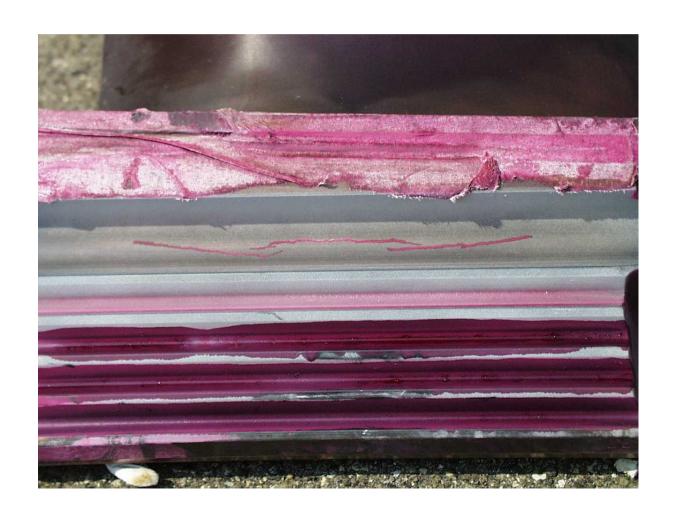
TYPICAL CRACKS DETECTED ON SHANK AREA OF 4TH STAGE BUCKETS

- 4TH STAGE BLADE BASE MATERIAL WAS COMPLYING WITH MANUFACTURERS SPECIFICATION AND NO ORIGIN DEFECTS WERE FOUND
- THE 4TH STAGE BLADE WAS "AS DESIGNED"
- THE CAUSE OF THE FAILURE SHOULD HAVE BEEN CYCLICAL STRESSES OF RELEVANT INTENSITY AND OF BENDING TYPE, WHICH LET THE 4^{TH} STAGE BLADE VIBRATE AT THE NATURAL FREQUENCY OF 172 Hz
- ONLY DLN GTs WERE FOUND AFFECTED BY THE FAILURE

- 2-125 MW GAS TURBINES OF ENEL FLEET EXPERIENCED CRACKS ON 4TH STAGE BLADE ROOTS (IN ONE CASE THE IN SERVICE-FAILURE OF A BLADE OCCURRED)
- DLN PRESSURE PULSATIONS ARE THE CAUSE OF THE FAILURE
- IN ORDER TO AVOID SIMILAR FAILURES ENEL FORESEES THE FOLLOWING DETECTING TECHNOLOGIES:
 - 4TH STAGE BLADE INSPECTIONS BY UT TECHNIQUE EVERY 8000 EOH (ONLY FOR DLN UNITS)
 - THE ON-LINE MONITORING OF PRESSURE PULSATIONS IN THE COMBUSTION CHAMBERS

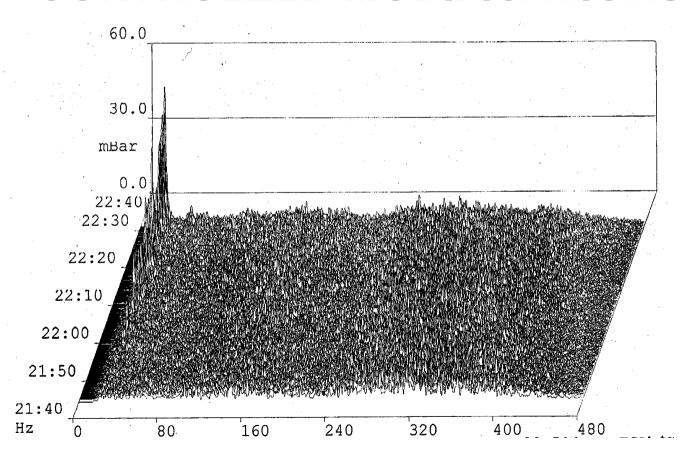
- THE DLN MAIN PARAMETERS OF ENEL GTs LIKE SIMILAR TO FAILED ONE ARE "ON DESIGN"
- DURING THE SERVICE WITH "ON DESIGN" DLN PARAMETERS PRESSURE PULSATION VALUES DANGEROUS FOR 4TH STAGE BLADE WERE NOT DETECTED
- BY THE REDUCTION OF P/T PARAMETER WITH RESPECT TO DESIGN VALUE AN INCREASE OF THE 23 Hz-PRESSURE PULSATION LEVEL WAS NOTICED
- (23Hz IS A FREQUENCY ABLE TO EXCITE THE NATURAL VIBRATION FREQUENCY (173 Hz) OF 4TH STAGE BLADE OF GTS SIMILAR TO FAILED ONE: 173=23+3*50)

23 Hz- PRESSURE PULSATIONS PRODUCED BY DLN DURING P/T CONTROLLED MODIFICATIONS

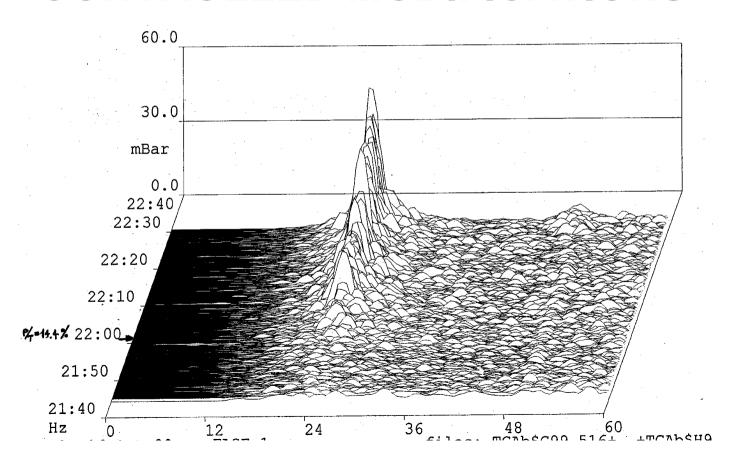
23 Hz- PRESSURE PULSATIONS PRODUCED BY DLN DURING P/T CONTROLLED MODIFICATIONS

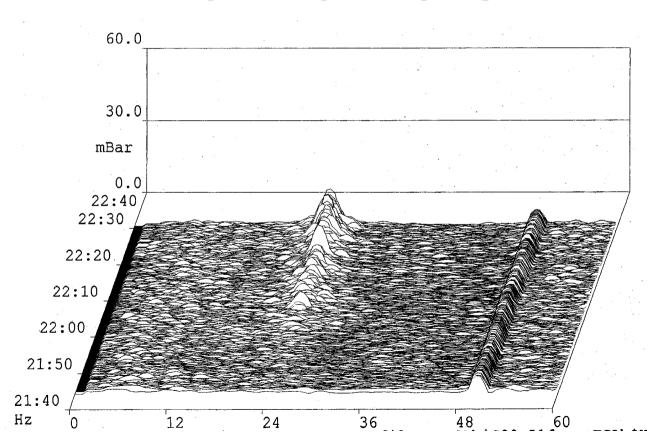
23 HZ-TURBINE EXHAUST-GAS DYNAMIC PRESSURE PRODUCED DURING P/T MODIFICATIONS

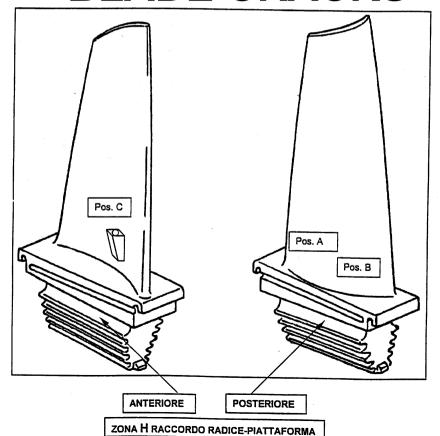
UT TECNIQUE APPLIED FOR THE EARLY DETECTION OF 4TH STAGE BLADE CRACKS

- THE UT TECNIQUE TUNED UP IN ORDER TO PREVENT THE 4TH STAGE BLADE FAILURE CAN BE APPLIED WITHOUT THE TURBINE CASING REMOVAL ENTERING INTO THE TURBINE DISCHARGE DUCT THROUGH THE MANHOLE
- BECAUSE OF THE HCF CRACKS CAN BE INCUBATED AT THE BEGINNING AND NOT DETECTABLE BY UT TEST IF THE CRACK DEPTH IS LOWER THAN 3 mm, ENEL FORESEES TO CARRY OUT UT TESTS ON 4TH STAGE BLADE ROOTS EVERY 8000 EOHS DURING THE OUTAGE FOR COMBUSTION INSPECTION

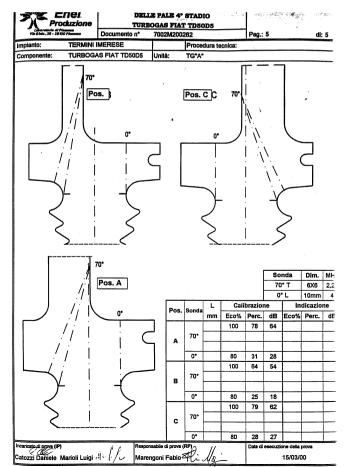
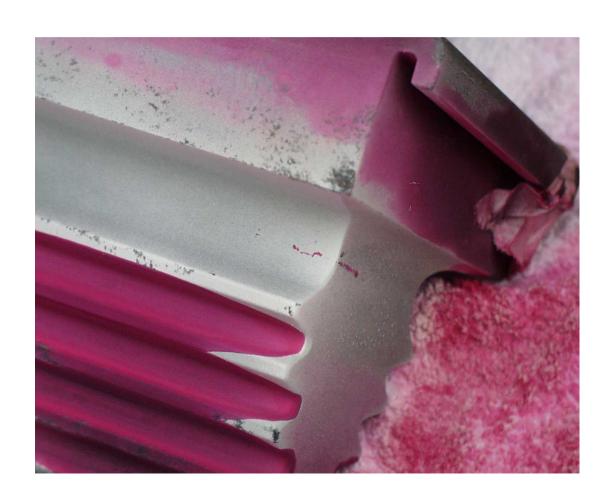
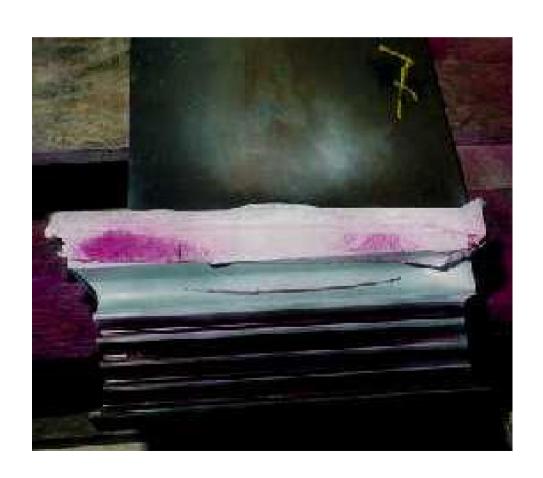
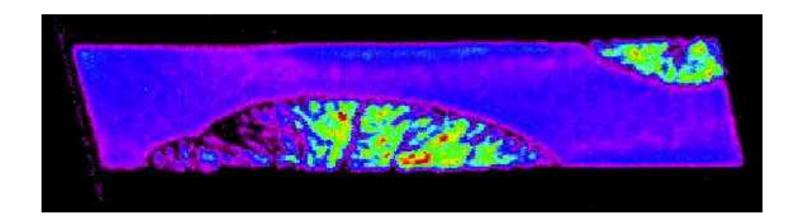
UT TECNIQUE APPLIED TO 4TH STAGE BLADE FAILURE

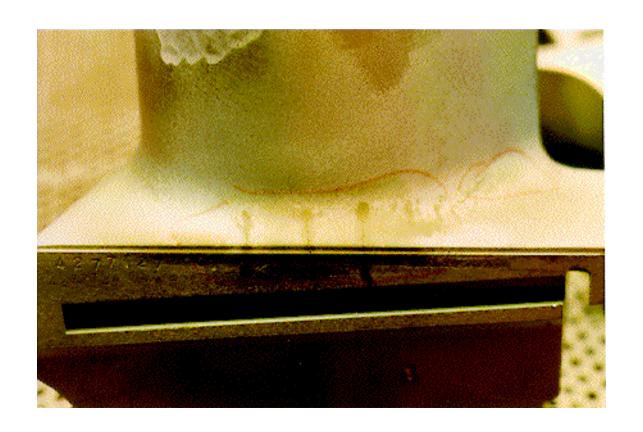
- THE PROBLEM WAS DETECTED ON 3 GTs;
- CRACKS ARE RADIAL, AND WERE DETECTED AFTER COATING
 STRIPPING ONLY, AND NOT BEFORE BY NORMAL FLUORESCENT DYE
 PENETRANT TEST;
- THE TYPE OF OPERATION AND THE SUPPLIERS OF THESE 3 ROWS ARE DIFFERENT;

CRACKS ON THE PLATFORM OF THE 1ST STAGE BLADES

- A GREAT CONTRIBUTE TO THE CRACK PROPAGATION WAS REPRESENTED BY THEMOMECHANICAL FATIGUE
- THE GAMMA PRIME PHASE ANALYSIS SUGGESTS THAT IN 2 CASES OF THE 3 ONES EXPERIENCED THE BLADES WERE EXPOSED TO EXCESSIVE TEMPERATURE
- IN THE THIRD EXPERIENCED CASE, UNCORRECT BLADE COOLING IS SUSPECTED
- ANOTHER CONTRIBUTE TO THE CRACK PROPAGATION WAS PROBABLY REPRESENTED BY THE ABSENCE OF RELIEVING TREATMENT OF MATERIAL PRIOR TO BLADE COATING STRIPPING

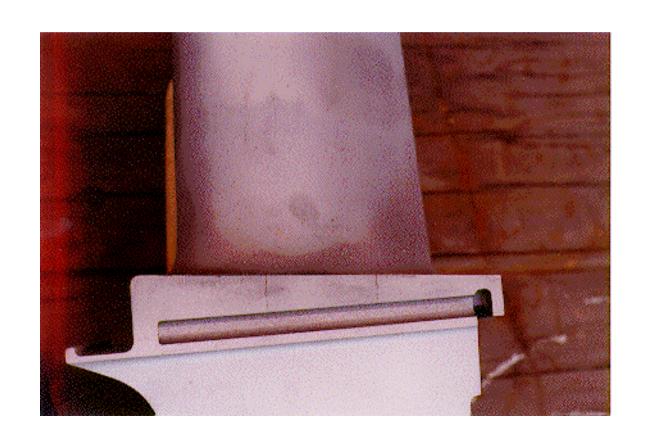
CRACKS ON THE PLATFORM OF THE 1ST STAGE BLADES

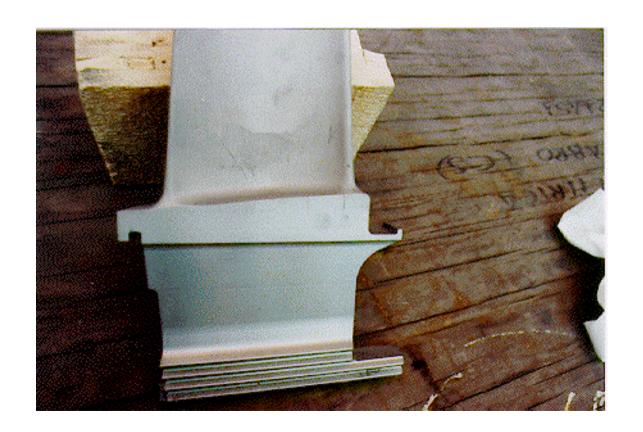
CRACKS ON THE PLATFORM OF THE 1ST STAGE BLADES

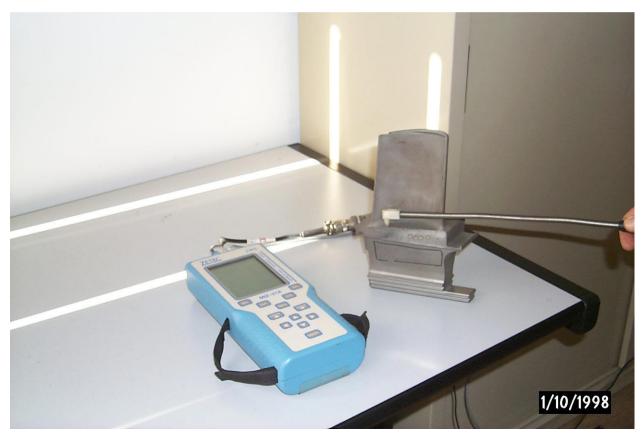
EDDY CURRENT TEST APPLIED TO 1ST STAGE BLADE CRACKS

- IN ORDER TO DETECT THE CRACKS UNDER THE COATING, ENEL TUNED
 UP AN EDDY CURRENT TEST
- IN ORDER TO ANALYZE THE 1ST STAGE BLADE PLATFORMS, ENEL
 UTILIZES THIS TEST WITHOUT BLADE REMOVAL EVERY 8000 HOURS
 DURING THE COMBUSTION INSPECTIONS (ONLY FOR FIAT GTs, IS
 POSSIBLE TO REMOVE 1ST STAGE VANES WHITHOUT REMOVING THE
 CASING)

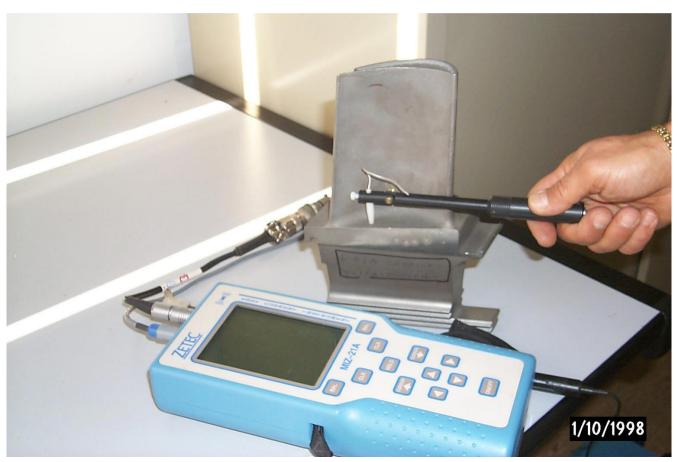
EDDY CURRENT TEST APPLIED TO 1ST STAGE BLADE CRACKS
